**ACCIAIERIE VALBRUNA SpA**

**SURFACE REBAR CONTAMINATION**

### **The effects of surface rusting in Stainless steel rebar .**

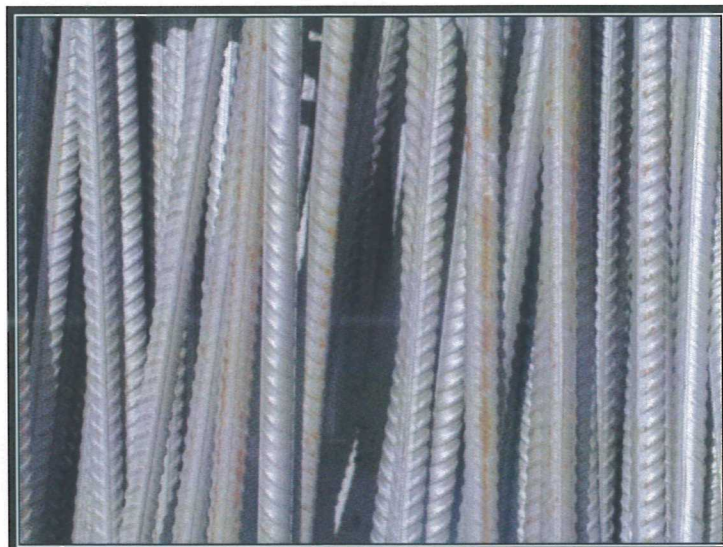
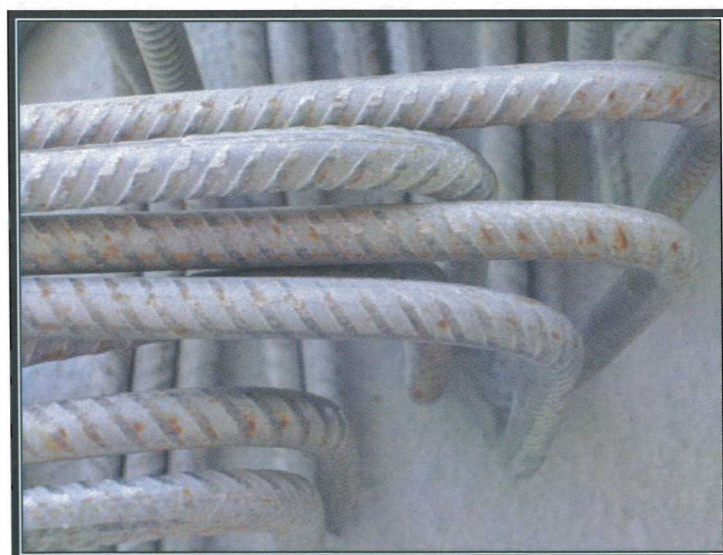
During handling , transportation, cutting & bending and storage , Stainless steel rebar could show some sign of rust in some part.

Point n°1 : The rusting is not coming from stainless steel but from small steel particles in the bar surface after the operations. **The presence of this steel rusting don't affects the corrosion resistance of stainless steel.** As a matter of fact , when the bar is inside the concrete, the alkalinity around the bar, reinforces the passivity condition and has the same behaviour to the stainless steel rebars in the concrete without surface rusting .

The presence of this kind of rust is obviously not conform from an aesthetic and psychological point of view, but it doesn't mean that it decreases the corrosion resistance of stainless steel.

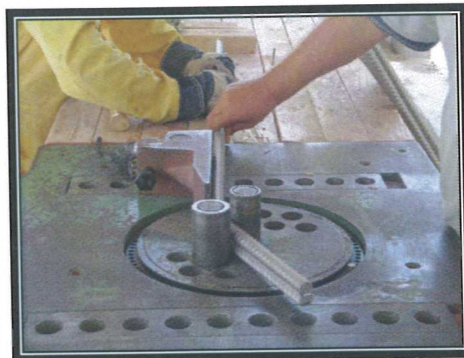
the bending machine must be clean of carbon contamination

- All hand tools should be stainless tools that have not been previously used on carbon steel. Before cutting and bending stainless rebar on the normal equipment it is recommended to clean properly the machine.

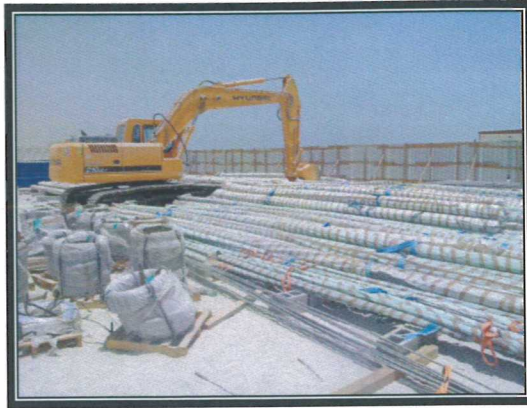
stainless steel rebars must be covered with nylon during storage at the job site and wooden/concrete support separate it from the floor

- All chains and steel bands should not come into direct contact with the stainless steel rebars.
- When carbon steel and stainless steel rebars must be shipped one on top of the other, the stainless steel rebars should be loaded on top and use wooden spacers to separate the two materials.
- Outside storage is acceptable using some covering (nylon or polypropylene) if dry conditions are assured.
- Stainless steel bars should be stored off the ground or shop floor on wooden supports. Stainless should be stored separately from carbon steel rebars.
- Keep carbon steel tools, chains, slings, etc. off stainless steel rebars.
- Do not use carbon steel lifting devices. Use nylon or polypropylene slings.

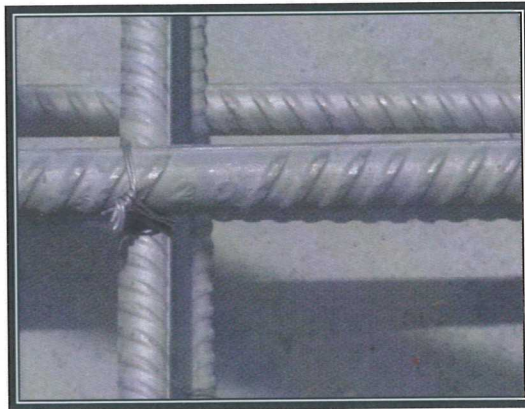
rebars must be hold together with stainless steel tie wire

- Shaped rebars are often shipped to the job site in bundles, held together with wire. In the case of stainless steel rebars, the bundling wire should be plastic coated or should be made of stainless steel. Do not use carbon steel ties.

- Particular attention during the placement is required using tie wire in stainless steel.
